THE AUTOMOTIVE LIGHTING BENCHMARK

# 2015+ MOPAR-SPEC ELITE HID SYSTEM INSTALL GUIDE

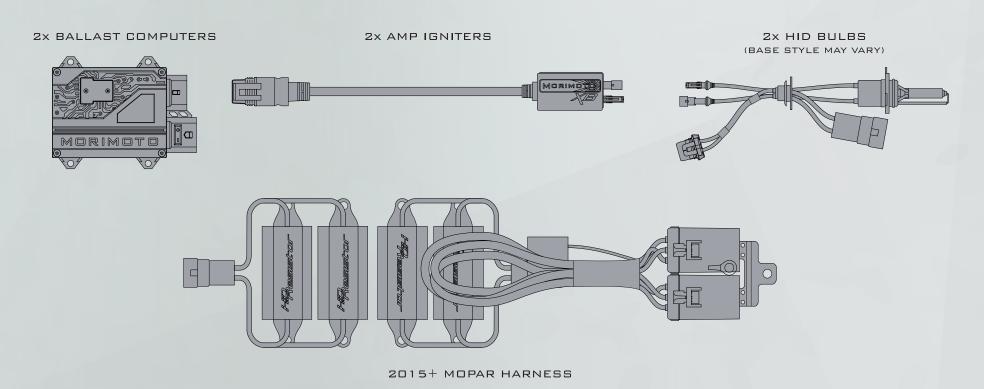
STANDARD PARTS

## PARTS IDENTIFICATION

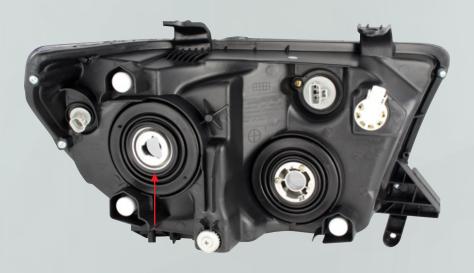
## EXTERNALLY-WIRED HEADLIGHTS

Your headlights are externally wired when you can access the bulb from the back of the headlight without removing any caps or covers. Wiring for the bulb is visible and accessible outside of the housing.

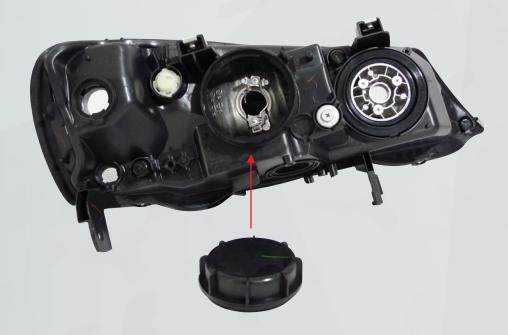
## INTERNALLY-WIRED HEADLIGHTS

Your headlights are internally wired when you must first remove a cap (generally plastic) to access the bulb. Inside the housing, there is wiring going to the bulb.

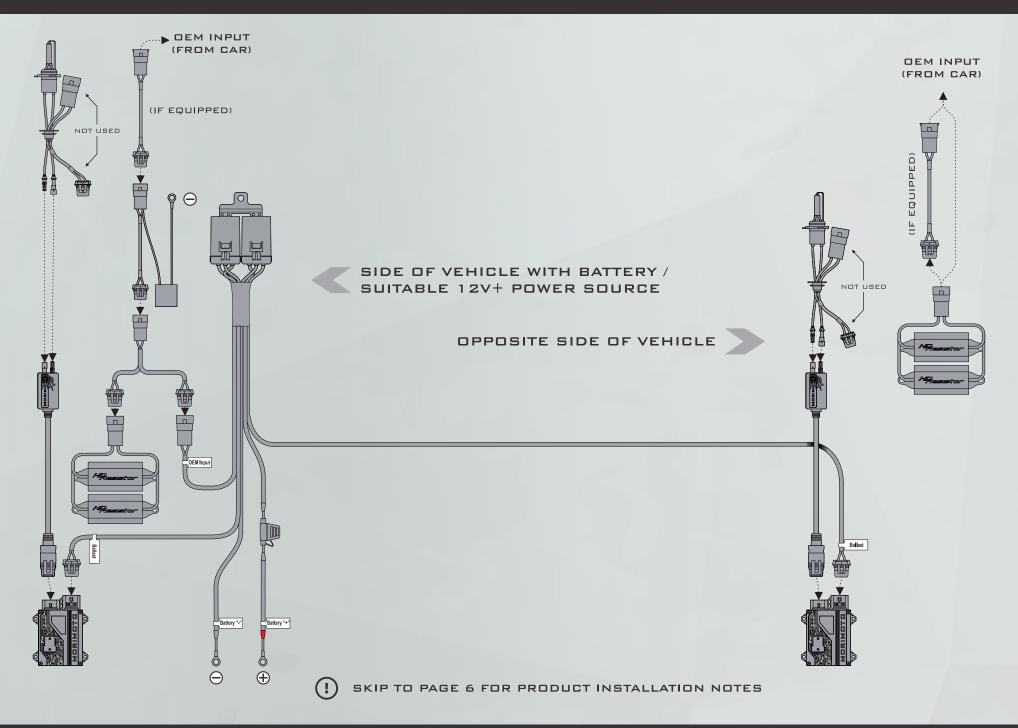
# **EXTERNALLY-WIRED HEADLIGHT DIAGRAM**

NOTE: System diagrams are to be used for reference purposes only. If you are unsure of the installation procedure for any single part, review that part's installation procedure prior to proceeding.

#### SKIP TO PAGE 4 FOR DIAGRAM

If noted as "not used" in your relevant install diagram, the pass-through wiring can be cut off and removed.
